Trouble shooting process for S series Range

1. The fault list

| Description of issue | Troubleshooting process |
|---|---|
| THE PILOT LIGHT WON'T STAY LIT | Step 1 to step 6 |

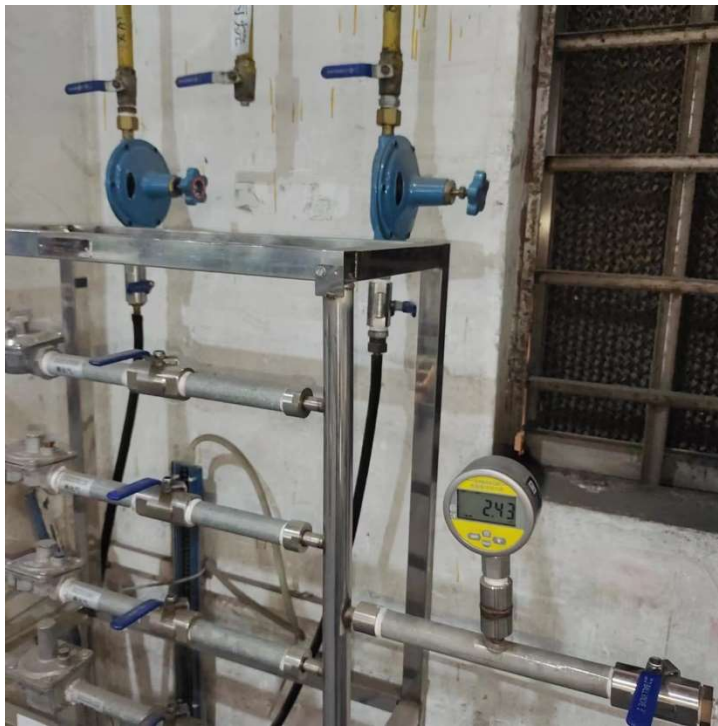
Step 1

Check the gas type and pressure in the inlet pipe, change the gas type or adjust gas pressure if they don't conform to the user's manual.

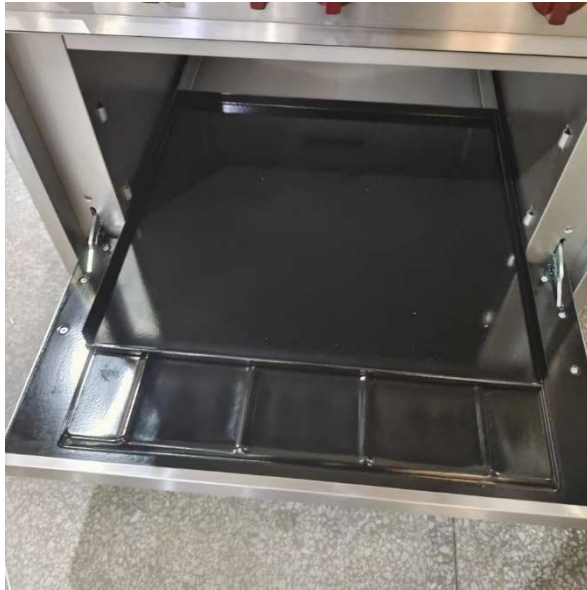
Step 2

Take out the baking frame, the bracket, and the bottom plate from

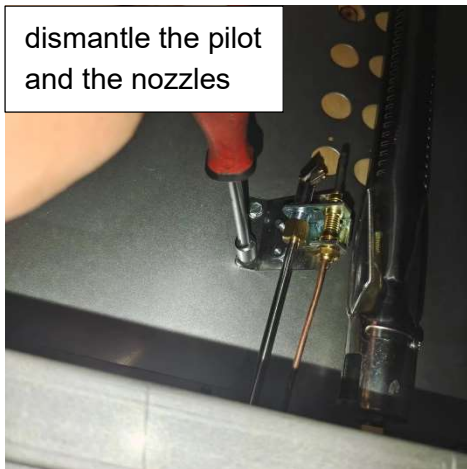
dismantle the pilot and the nozzles

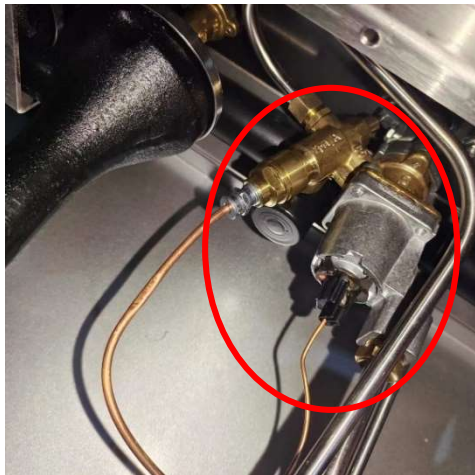
If confirmed that the pilot nozzle is not blocked, and still unable to ignite the pilot, , the gas valve needs to be replaced.

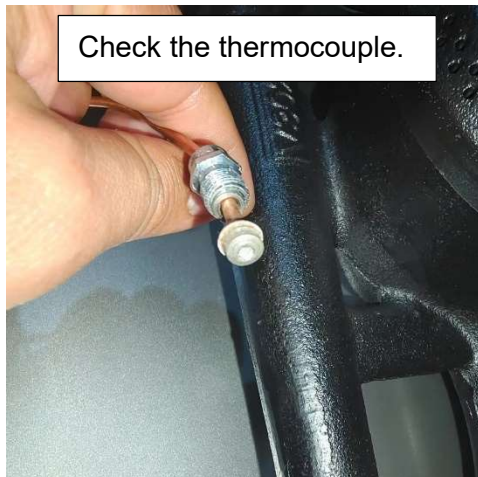
- If the trouble still occurs, you should remove the thermocouple connector from the gas valve end, and clean the end of the thermocouple with a cloth and reinstall it for locking.

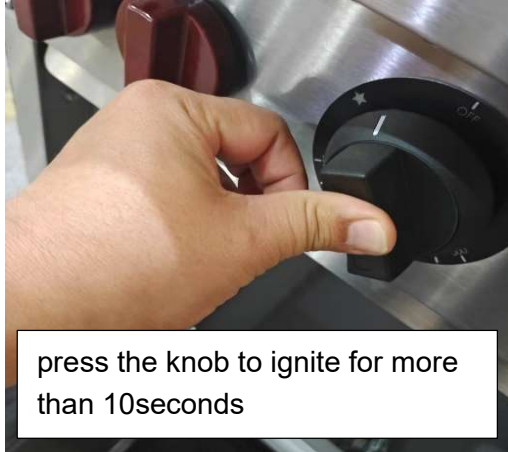
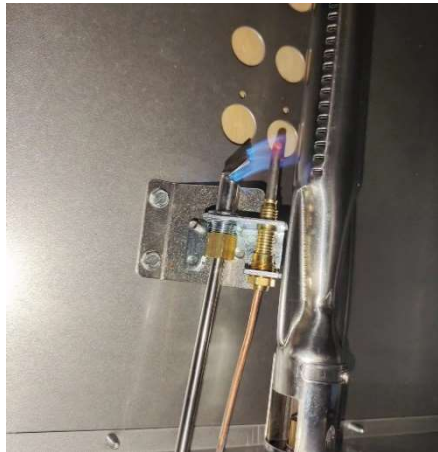
- If the trouble still occurs,, Remove the thermocouple connector at the gas valve end again, light the pilot, and continuously press the knob to ignite for more than 10 seconds. Measure the thermoelectric voltage of thermocouples, it must be greater than 24mv, otherwise the thermocouple needs to be replaced.
